DEPARTMENT OF TRANSPORTATION**DIVISION OF ENGINEERING SERVICES**

Quality Assurance and Source Inspection

Contract #: 04-0120F4Cty: SF/ALA Rte: 80 PM: 13.2/13.9File #: 1.28**WELDING INSPECTION REPORT****Resident Engineer:**Pursell, Gary**Address:** 333 Burma Road**City:** Oakland, CA 94607**Report No:** WIR-012635**Date Inspected:** 11-Mar-2010**Project Name:** SAS Superstructure**OSM Arrival Time:** 630**Prime Contractor:** American Bridge/Fluor Enterprises, a JV**OSM Departure Time:** 1500**Contractor:** American Bridge/Fluor Enterprises, a JV**Location:** Job Site

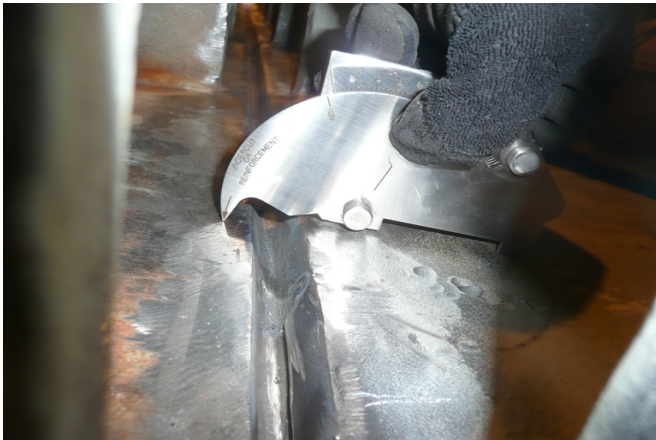
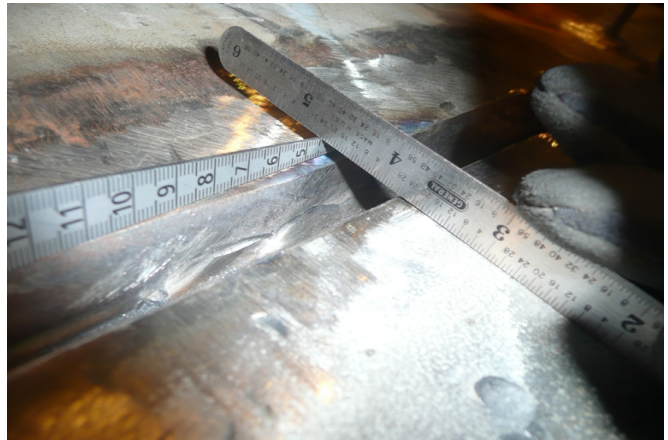
The QA Inspector randomly observed the ABF welders Rory Hogan and Jeremy Doleman setting up the flux cored arc welding (FCAW) machines at the above identified weld joint. The QA Inspector randomly observed an area of the weld joint where the longitudinal weld intersected with the transverse weld splice identified above. The QA Inspector performed dimensional measurements of the off set of the two members, it was observed by the QA Inspector the intersected area of the transverse weld splice 1E/2E-C and the longitudinal weld had an off set of 6mm. The QA Inspector continued to perform the dimensional measurements and observed the weld joint was not in compliance with the dimensional tolerances of AWS D1.5-02. The QA Inspector noted the off set of the two members was 3.5mm-4mm, the QA Inspector noted the maximum allowable off set for the weld joint is 2mm. The QA Inspector noted the area of the weld joint which was not in compliance with the contract requirements was approximately 2100mm in length. The QA Inspector noted the non complaint area was 2100mm long beginning at the top "T" stiffener and extending downward 2100mm. The QA Inspector informed the Smith Emery (SE) Quality Control (QC) Inspector Bernard Docena of the issue described above (see summary of conversations). The QA Inspector noted the QC Inspector left the area of welding to inform the ABF representative John Callaghan.

The QA Inspector randomly observed Mr. Callahan instruct the ABF welders Rory Hogan and Jeremy Doleman re-install the splice plate in the area where the off set had occurred. The QA Inspector observed the ABF welder Rick Clayborn perform additional fit up and install additional pins to the fit gear to correct the off set members. After the additional fit was performed, the QA Inspector observed the off set had been corrected in all areas of the original 2100mm except for the area at the intersection of the longitudinal weld. The QA Inspector performed additional dimensional verifications after the QC Inspector Jesse Cayabayab had informed the QA Inspector the off set had been nearly corrected. The QA Inspector noted the off set in the area of the intersection of the longitudinal weld still remained at 5mm at the end of the QA Inspectors shift. The QA Inspector noted the ABF welders had stopped the FCAW fill passes short of the area where the off set was previously determined to be unacceptable. The QA Inspector noted the ABF welders had three to four passes of fill in the weld joint beginning at the area where previously welded extending approximately 2.5 meters upward.

The SE QC Inspector Jesse Cayabayab later informed the QA Inspector he observed pins associated with the fit up gear, appeared to have been removed. The QC Inspector went on to explain the joint was likely put out of tolerance due to the removal of the pins associated with the fit up gear. The QC Inspector informed the QA Inspector the off set had been corrected in all of the areas except for the areas next to the intersection of the longitudinal weld. The QC Inspector informed the QA Inspector the off set could not be corrected any more than the current condition of the joint.

Later in the shift, John Callaghan approached the QA Inspector and informed him the ABF welder Rick Clayborn will perform additional fit up tasks to ensure the weld joint was in compliance with AWS D1.5-02 bridge welding code. Mr. Callaghan informed the QA Inspector he became aggravated the weld joint was being inspected twice. The QA Inspector asked the Mr. Callaghan if he wanted to go on record stating what was previously said about weld joints current condition. Mr. Callaghan informed the QA Inspector he did not, and he was speaking previously in aggravation.
